Motorized Trail Safety Audit Report

Chequamegon-Nicolet National Forests

Great Divide Ranger District

Date:
August, 2011

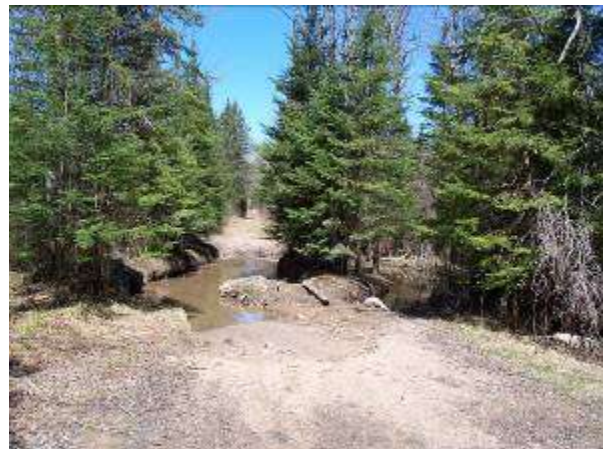
At MP 0.94 the trail passes through a short wetland crossing approximately 75 feet in length. The trail/road bed has failed resulting in a narrow water filled trough less than 5 feet wide and 3 feet deep (photo). Users have created a detour adjacent to the marked trail that is also troughed and impassable. Due to the width of ATV's, passage is possible with 4 wheel drive ATV. UTV's on the other hand would likely not be able to navigate through this short section due to the well defined deep narrow troughs. The remainder of the trail segment has little variation in vertical and horizontal alignment.

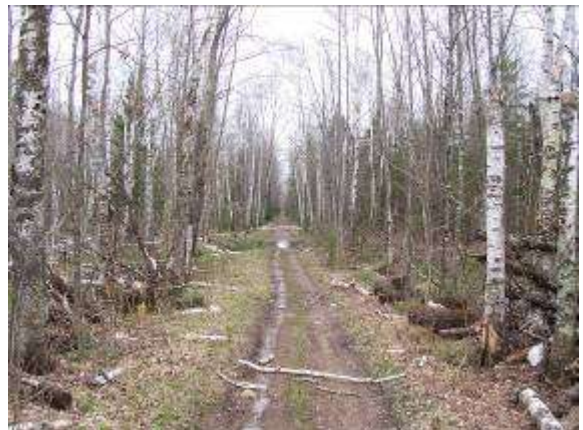
is a combination of native silt loam (Butternut) and aggregate. Unlike the previous trail segment horizontal alignment creates very limited sight distance on curves. Therefore this segment has been ranked moderate for design standard mitigation.

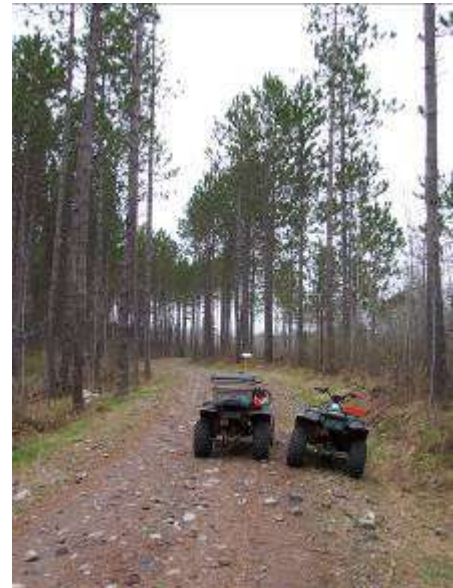
From MP 0.78 to MP 3.39 the trail has a tread width 14 feet wide. Clearing limits average 20 to 22 feet. Surface is aggregate. This trail segment was relocated and reconstructed in 2008 (photo). Although there are nine instances where corner clearing have been identified and recommended, the wide tread width allows for an added level of safety when oncoming vehicles are encountered, therefore this trail segment has been ranked low for mitigation, and meets standards for UTV.

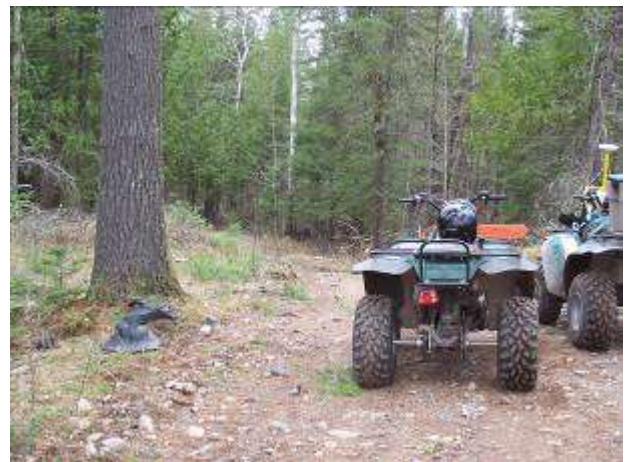
From MP 0.42 to MP 0.74 trail tread width averages 8 to 10 feet. Clearing limits average 16 feet. Surface is a good mix pit run aggregate. This segment of trail has 6 instances where horizontal and vertical curves create sight distance less than 50 feet. Trail surface condition is such that increased vehicle speeds are likely to occur on this segment. At MP 0.67 a crash site was documented (see photo). A low radius horizontal and vertical curve at this location in combination with a large white pine immediately adjacent to the trail creates the hazard. A recommendation for mitigation at this location involves increasing the vertical and horizontal curve radii. Ranking for mitigation at and adjacent to the crash site is high. Clearing to improve site distance on 5 additional curves has resulted in a moderate ranking for the remainder of this trail segment.

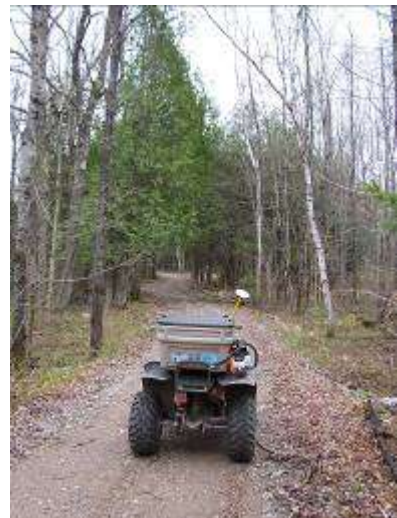
From MP 0.03 to MP 0.68 the trail runs coincident with a ML 2 road (FR 166B). Tread width averages 10 feet wide. Clearing limits varies from 12 feet to 20 feet. Surface is pit run aggregate. As a result of recent reconstruction, that did not re-establish previous clearing limits, sight distance is limited on six horizontal curves (photo). Due primarily to a very good running surface, the author observed ATV traffic on this segment traveling at speeds that exceed what is considered safe and prudent. As a result this segment has been ranked moderate for mitigating sight distance limitations on horizontal curves.

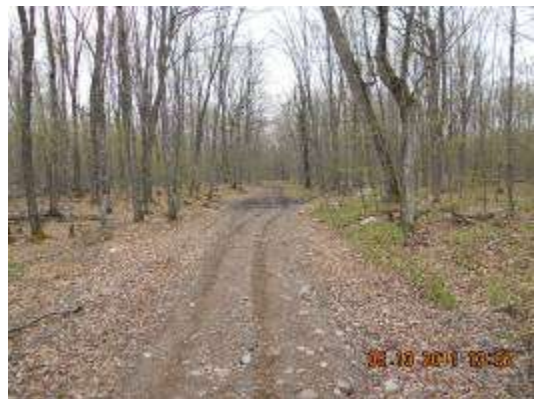
From MP 0.17 to MP 0.45 tread width averages 8 feet wide. Clearing limits average 16 feet. Surface varies from pit run aggregate to fine sandy loam (Shanagolden). No deficiencies have been identified for this trail segment. As a result ranking for mitigation is low. This segment would be suitable for UTV designation (photo).

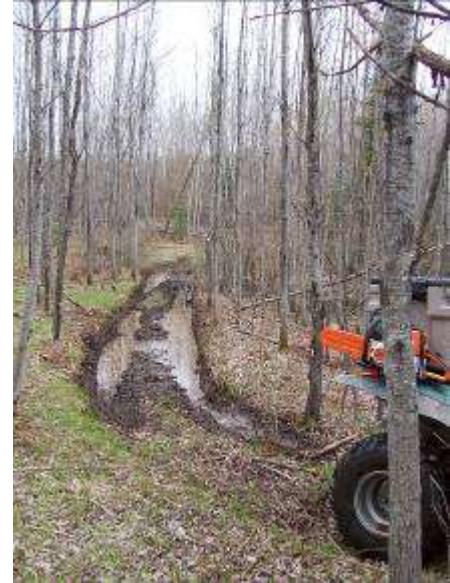
From MP 3.82 to DH 5 at MP 3.88 tread width varies from 6 feet to 12 feet. Clearing limits vary from 11 to 16 feet. Surface is native loamy fine sand (Karlin). During wet periods, this segment has an impassable segment that is bypassed by a user developed detour. The detour has less than 5 feet of clearance between trees that makes it physically impossible to accommodate a UTV (photo). The detour is also nearly impassable due to water and mud. The result is a high ranking for mitigation.

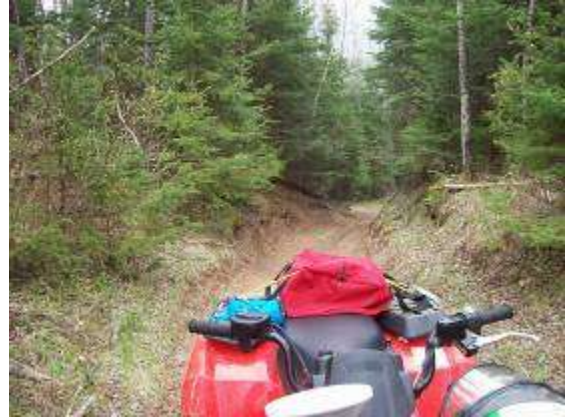
From MP 2.66 to MP 2.8 tread width varies from 5 feet to 8 feet. Clearing limits vary from 9 feet to 16 feet. Surface is native sandy loam (Padus). This trail segment has limited sight distance throughout all curves (photo at right). The narrow tread width also limits the passage with oncoming vehicles. The result is a high ranking for mitigation that would require brushing throughout as well as increased tread width.

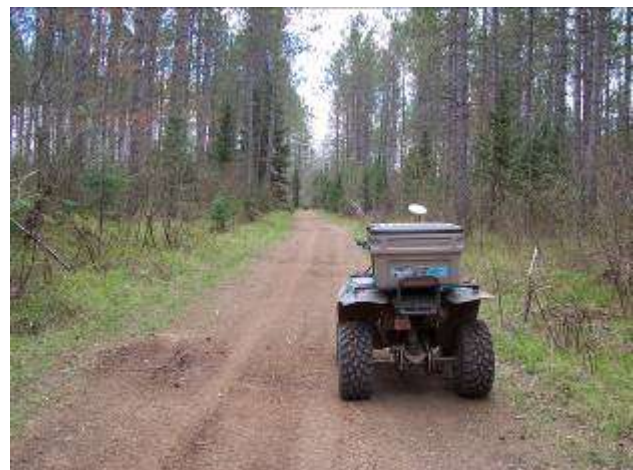
From MP 1.15 to MP 1.93 tread width averages 8 feet. Clearing limits average 18 feet. Surface is native sandy loam (Padus, Stanberry). Although tread width and clearing limits as measured are adequate and meet design standards, trail condition due to rutting, standing water, combined with no less than 10 locations where sight distance is limited (photo), mitigation ranking is moderate.

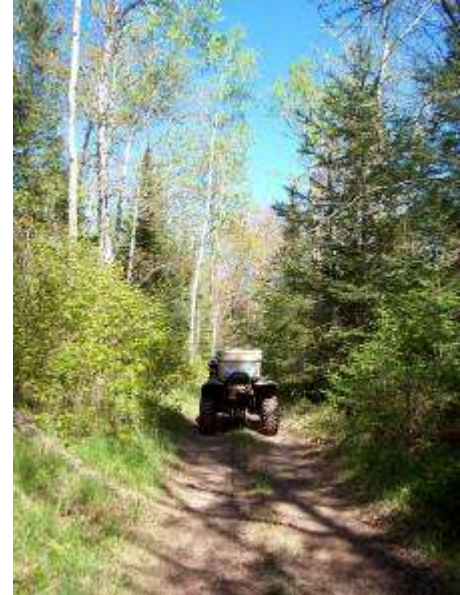
From MP 4.12 to MP 4.39 (DH 9) tread width averages 6 feet. Clearing limits average 10 feet. Surface varies from aggregate to native sandy loam (Padus-Karlin). This segment has two locations where specific mitigation has been identified. Although tread width and clearing limits meet minimum design standards, it would be difficult for oncoming vehicles to pass on this segment (photo). Therefore the mitigation ranking for this segment is moderate.

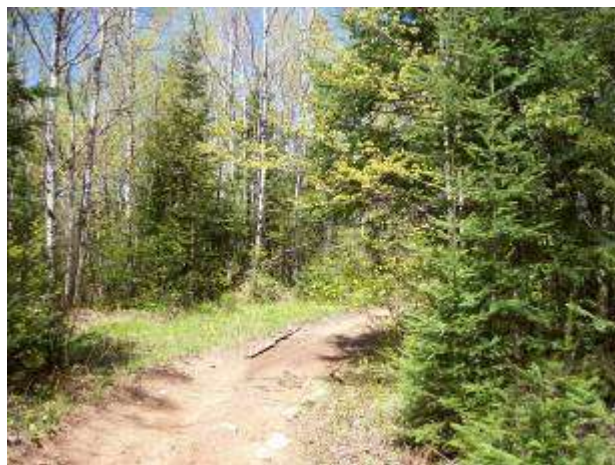
From MP 3.76 to MP 4.08 tread width is 5 to 6 feet. Clearing limits are 13 feet. Surface ranges from pit run aggregate to native sandy loam (Keweenaw-Pence). This segment has a winding horizontal alignment with three locations where sight distance is severely limited on curves (photo). The result is a high ranking for mitigation.

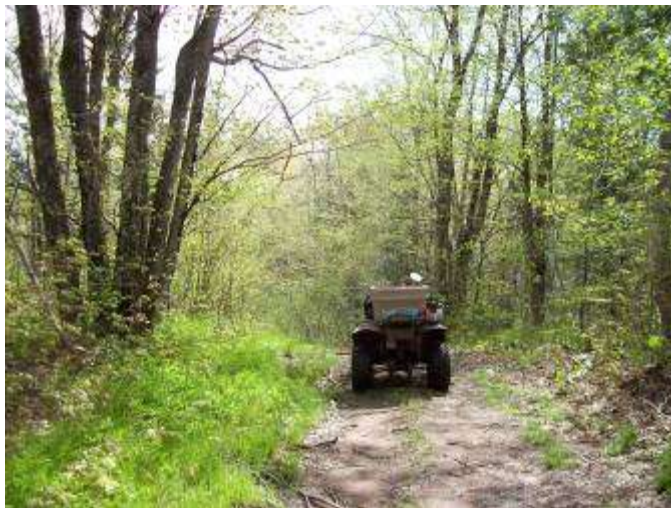
From MP 4.27 to MP 4.48 tread width varies from 6 to 9 feet. Clearing limits vary from 14 feet to 18 feet. Surface ranges from native sandy loam (Keweenaw-Pence) to native silt loam (Minocqua-Wozny-Pleine). This trail segment has a vertical and horizontal alignment that severely limits sight distance. Five locations have been identified where clearing or earthwork is recommended. A crash site with vehicle parts was also identified on this segment (photo). The result is a high ranking for mitigation.

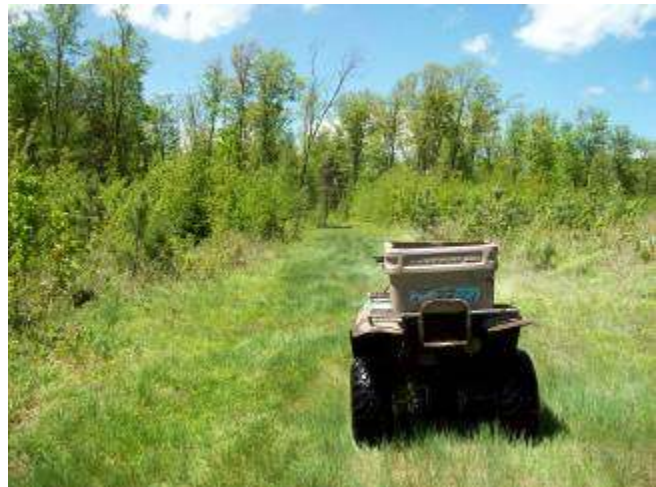
From MP 0.60 to MP 1.60 tread width averages 8 feet. Clearing limits average 22 feet. Surface ranges from pit run aggregate to native silt loam (Butternut). As a result of this trail segment exceeding design parameters throughout, a low ranking for mitigation has been assigned (photo). All recommendations on this segment are for drainage structures and do not impede safety.

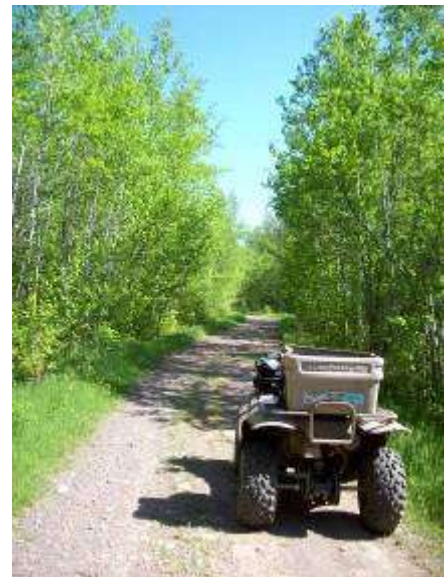
From MP 3.49 to MP 5.40 the trail runs coincident with specified logging roads constructed by a private timber company (photo). Tread width on this segment varies from 8 to 10 feet. Clearing limits vary from 18 to 22 feet. Surface is pit run aggregate. One location has been identified for mitigation that involves replacing a drainage structure. No instances of deficient existing design standards were observed. The result is a low ranking for mitigation. This trail segment would be suitable for UTV designation.

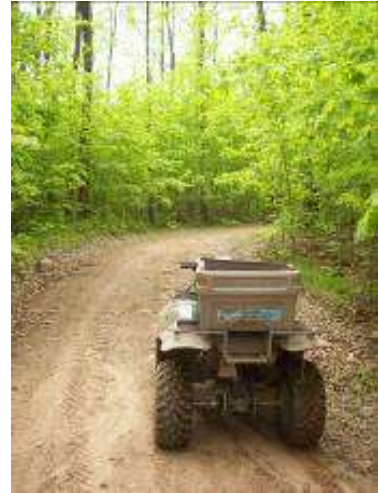
From MP 0.55 to MP 0.60 tread width remains 8 feet. Clearing limits also remain at 16 feet. Surface is once again native sandy loam (Padus-Karlin). This short segment has two locations where small radius horizontal curves severely limit sight distance (photo at right), resulting in a moderate ranking for mitigation.

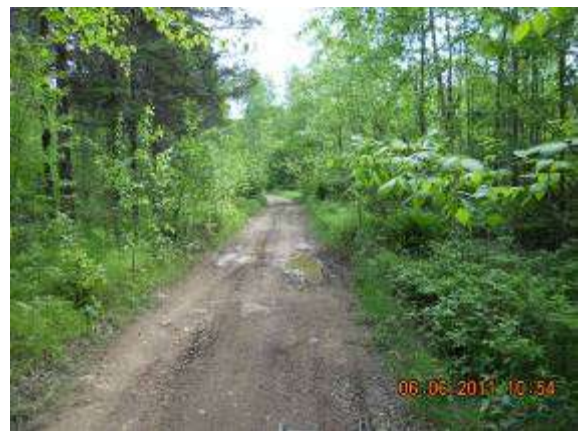
From MP 1.73 to MP 2.58 tread width varies from 7 to 9 feet. Clearing limits vary from 12 to 16 feet. Surface ranges from pit run aggregate to native sandy loam (Keweenaw-Pence). This segment runs coincident with FR 306B (ML 2) and FR 306 (ML 2). Although this segment exceeds minimum design parameters, eighteen locations have been identified where sight distance is limited on horizontal curves. That combined with the fact that this segment allows motorized mixed use, has resulted in a moderate ranking for mitigation (photo).

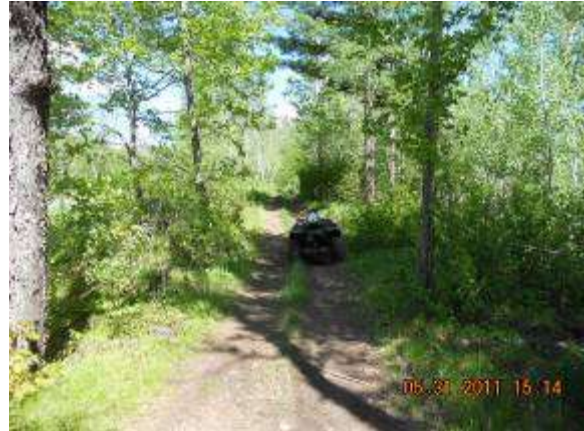
From MP 0.65 to MP 0.91 tread width varies from 6 to 8 feet. Clearing limits vary from 10 to 12 feet (photo). Surface ranges from pit run aggregate to native fine sandy loam (Shanagolden). Although this segment meets minimum design standards, four locations have been identified where sight distance is limited on horizontal curves. The result is a moderate ranking for mitigation.

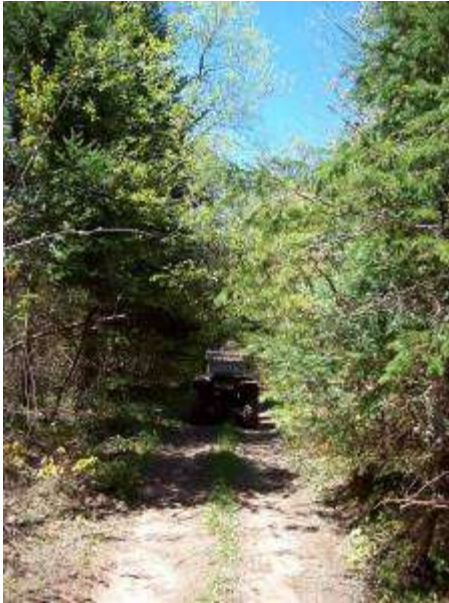
Photo C-1
Example of narrow tread width coupled with narrow clearing limits

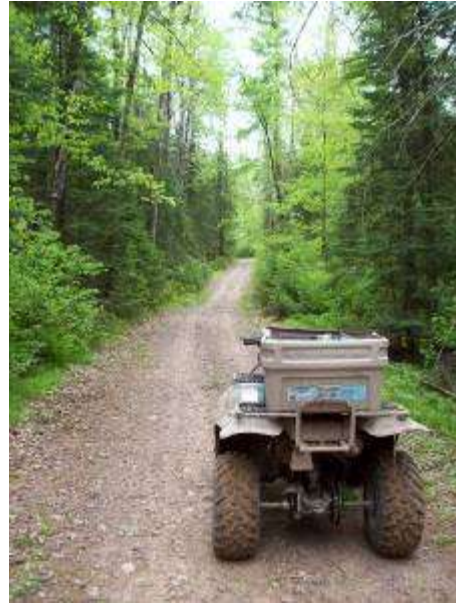
Example of tread width exceeding minimum standards with adequate clearing limits (ideal situation)

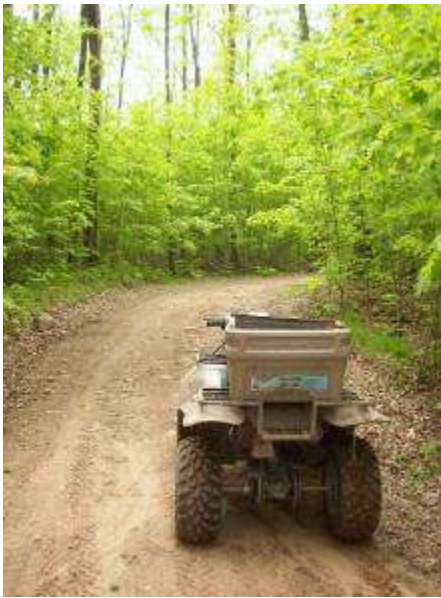
Photo C-3
Example of limited sight distance on horizontal curve (10 feet)

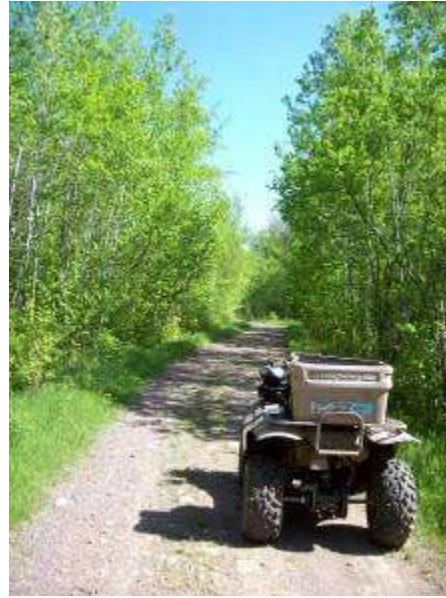
Photo C-4
Example of large radius curves (>100 feet)

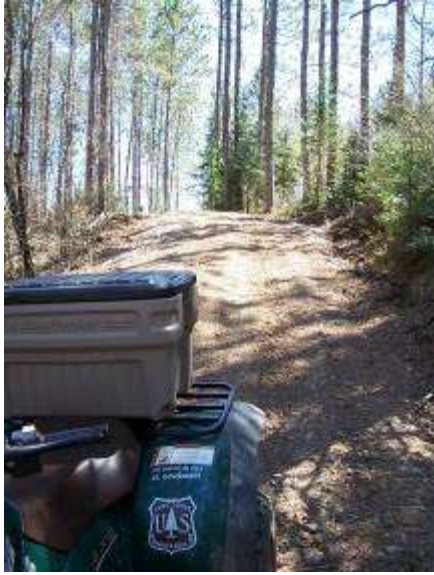
Photo C-5
Example of limited sight distance on
Vertical curve (15 feet)

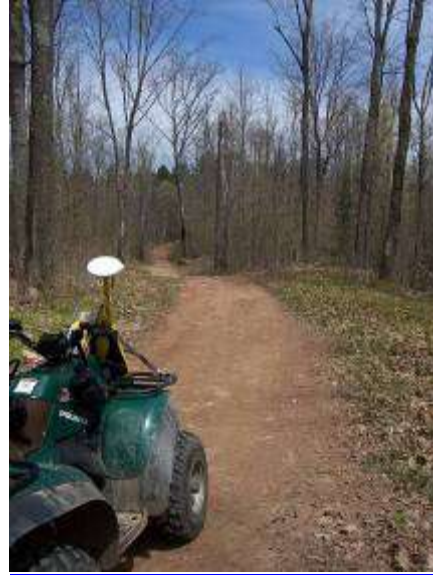
Photo C-6
Example of large radius vertical curve
